THERMACELL® PRO

Troubleshooting LIV App Onboarding Failures

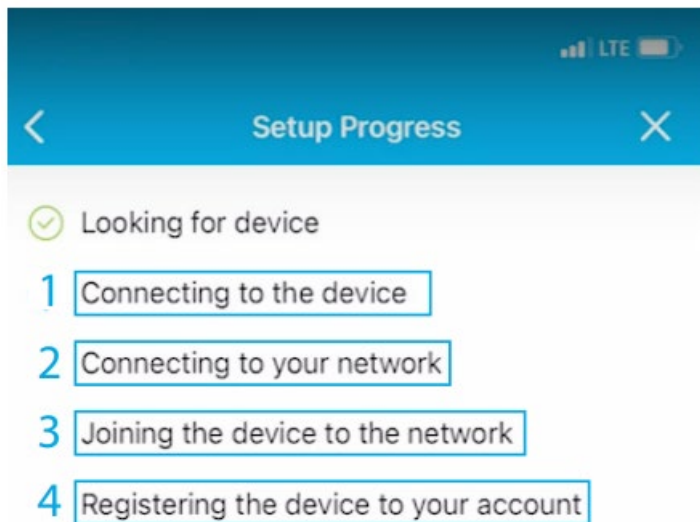
1. If the device fails at this step, try to get closer to the Wi-Fi router and try again. If it continuously fails at this step, it may be a faulty Hub.
2. When a device fails at this step, it traditionally means the Wi-Fi network is not a 2.4 GHz network or it may not be enabled.
3. If continuously failing at this step, it is suggested to do a Wi-Fi speed test as the connection may not be suitable for LIV or any other smart home device.
4. Contact Thermacell Support and they will help get the customer registered manually if it continues to fail here after multiple attempts.
